# Crash Test of an MD-500 Helicopter with a Deployable Energy Absorber Concept

J. D. Littell\*, K. Jackson\*\*, S. Kellas\*\*

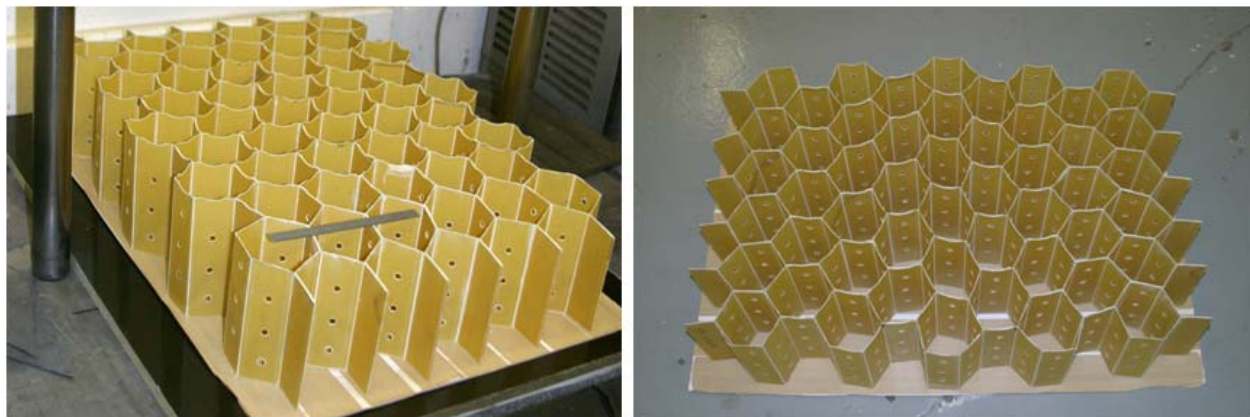
Figure 1 – An example DEA used in subscale testing. Isometric view (left) and top view (right).

At NASA LaRC, a program has been implemented to demonstrate a novel Deployable Energy Absorbing (DEA) composite honeycomb concept [15-17]. Originally considered for evaluation on NASA's Orion spacecraft, the DEA's were then considered in civil aircraft as a potential device to attenuate crash loads and to alleviate occupant injuries. The DEA used for this test was fabricated from Kevlar/epoxy composite sheets, and then assembled to form the hexagonal cell walls. The flexible hinge design allows the entire structure to lie flat until deployed, at which point the cells form a honeycomb shape oriented normal to the airframe and impact surface. Through a systematic building block approach, the DEA's cell walls, materials and geometry have been studied by conducting tests and analyses at the material, component, and subscale level. The crash test of a MD-500 helicopter, described herein is a proof-of-concept test, which gives researchers a chance to validate the concept on an actual airframe under realistic crash conditions. Figure 1 shows an example DEA used in a subscale crush test. Note these photos do not depict the actual DEA used in the helicopter test.

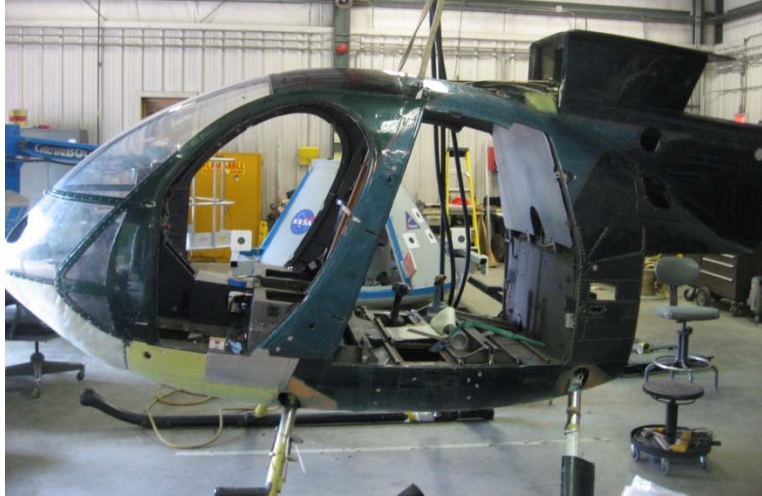
Figure 2 – As-delivered MD-500 helicopter.

The U.S. Army Mission Enhanced Little Bird program provided the MD-500 helicopter to LaRC. Components not included in the as-delivered helicopter were the engine, gear box, main rotor, rear tail and tail rotor, avionics, fuel tanks, seats, restraints and doors. Figure 2 shows the helicopter as delivered to NASA LaRC.

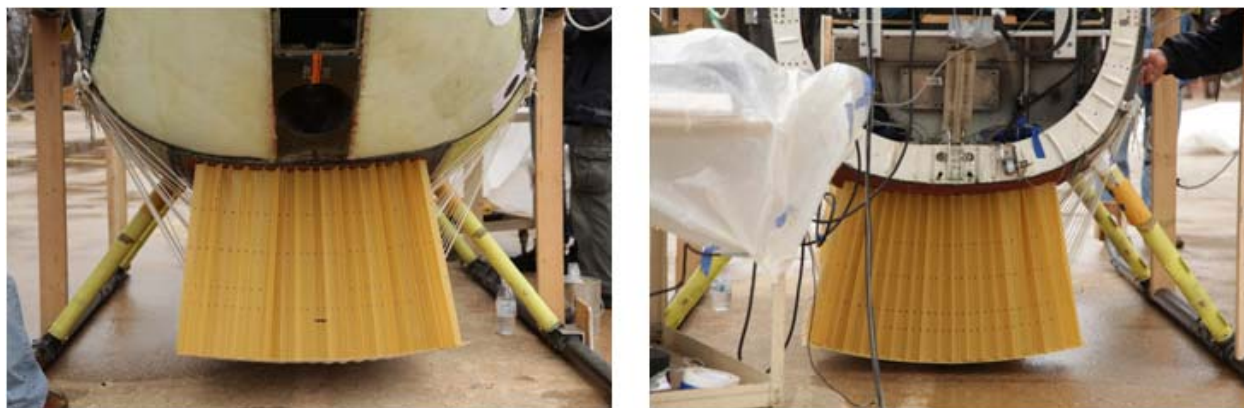
Figure 3 – Front (left) and Rear (right) DEA's fitted on the MD-500 helicopter.

The DEAs were designed and fabricated in-house at NASA LaRC. Two DEA configurations were used for the test; one for the front and one for the rear of the helicopter, as shown in Figure 3. Previously

conducted analyses [20] showed the maximum energy attenuation configuration for this test's combined velocity conditions was with both DEAs canted 20 degrees forward. However, geometric limitations of the airframe required that the rear DEA remain purely vertical. The DEAs were attached in a pre-deployed configuration. (They are designed to be stowed flat underneath the airframe and deploy only in the event of a crash.) For more on the deployment mechanisms considered, see Ref [9]. The deployed DEA blocks are tied to the previously mentioned aluminum straps with nylon cords.

The height of the front DEA was approximately 55.25 cm (21.75 in), and the width was 67.82 cm (26 in) on the end against the helicopter and 83.3 cm (32.8 in) on the free end. The front DEA covered approximately 82.3 cm (32.4 in) longitudinal distance of the helicopter and was fastened approximately between stations 44 and 78.50. For reference, the tip of the helicopter's nose is at station 15. There was approximately 17.8 cm (7 in) vertical clearance between the forward free end and the ground and approximately 10.2 cm (4 in) vertical clearance between the rearward free end and the ground.

The height of the rear DEA was approximately 46.7 cm (18.4 in), and it was 57.66 cm (22.7 in) wide on the end against the helicopter and 76.2 cm (30 in) on the free end. The rear DEA covered approximately 81.2 cm (32 in) longitudinal distance of the helicopter and was fastened between stations 100 and 130. There was 12.1 cm (4.75 in) of clearance between the front end and the ground and 7.6 cm (3 in) of clearance between the rear end and the ground. The specific height of both DEAs was intended to allow the skid gear to contact first, stabilizing the helicopter, and then the DEA's would subsequently attenuate the impact load. The combined weight of the front and rear DEAs was 14.42 kg (31.8 lbs).

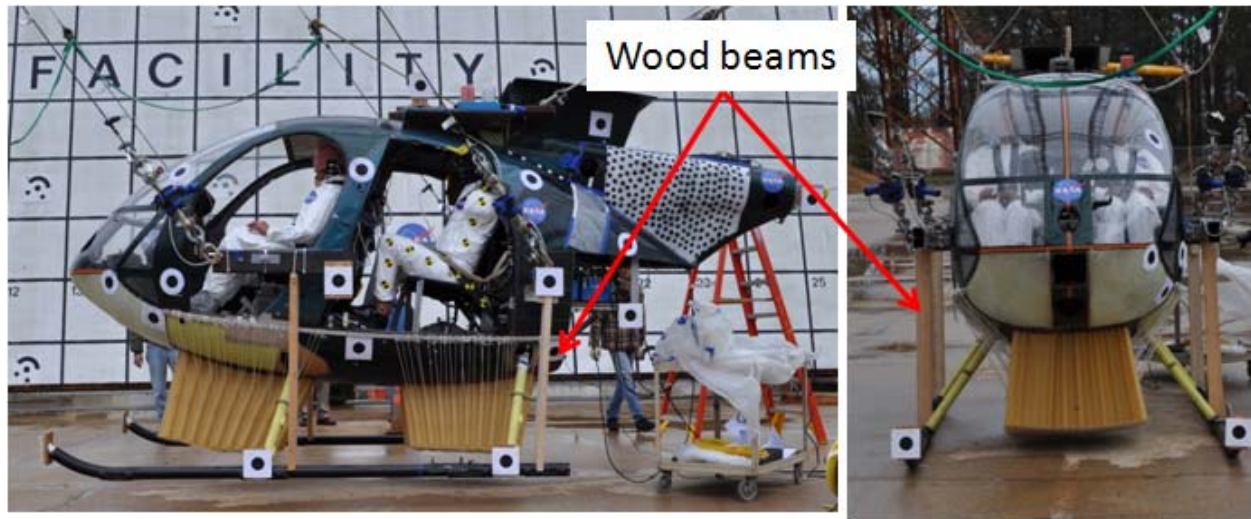
Figure 4 – MD-500 in test configuration. Side view (left) and front view (right).

The nominal helicopter impact conditions were 12.19 m/s (40 ft/s) horizontal velocity and 7.92 m/s (26 ft/s) vertical velocity, giving a resultant velocity of 14.54 m/s (47.7 ft/s) at a 33 degree glide angle. The impact surface was concrete. The particular velocity condition was chosen to represent a severe, but survivable crash, and not explicitly based on a particular standard such as MIL-STD-1290A [21]. The nominal impact velocity is achieved by swinging the helicopter through two sets of parallel swing cables, located on either side of the vehicle. A separate set of pullback cables lifts the vehicle to the specified drop height. A set of pyrotechnic cutters severs the pullback cables, allowing the vehicle to swing toward the ground via the swing cables. Immediately before impact, pyrotechnic cutters sever the swing cables such that the vehicle is in free fall. A picture of the MD-500 helicopter in the test configuration attached to LandIR cabling systems is shown in Figure 4. Wood supports between the skid gear and box beam cabling attachment structure are there for pretest support, and were removed prior to the test.

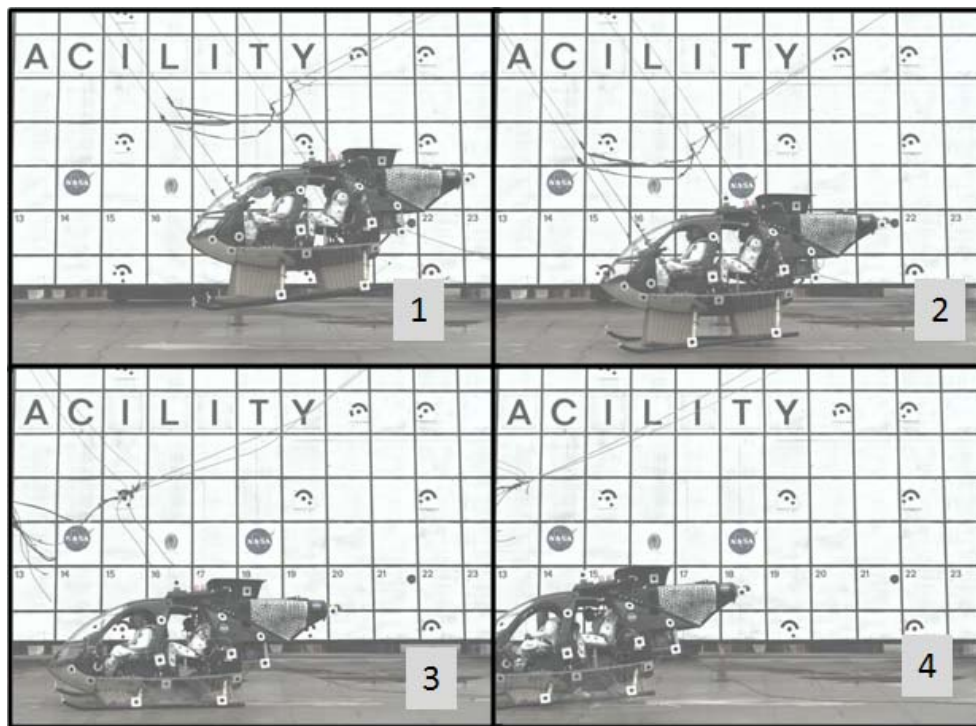
Figure 5 – Image sequence of impact.

External high speed cameras filming at 1000 frames per second were used to capture pre-, during-, and post- impact video. Helicopter impact conditions, as determined from the photogrammetry analysis, were 11.8 m/s (38.8 ft/s) forward and 7.8 m/s (25.6 ft/s) vertical velocities, 5.69 degrees pitch, 9.30 degrees yaw and 7.04 degrees roll with angular rates of 4.82 deg/s yaw and 1.11 deg/s roll. Figure 5 shows an image sequence through the impact obtained from the video capture.

In Figure 5, picture 1 (upper left) shows the helicopter approximately 30 ms before impact, picture 2 (upper right) shows the helicopter at the point of first skid gear impact, picture 3 (lower left) shows the point of maximum DEA crushing, and picture 4 (lower right) shows a post-impact rebound. The front-right side skid gear is seen to impact the ground first, which was caused by the yaw and roll present in the swing. At the point of maximum crush deflection (picture 3), the helicopter has straightened out to show almost no pitch. After the point of maximum crush, the nose is seen to pitch forward on the rebound, presumably due to friction between the DEA and the impact surface. The vehicle came to rest approximately 13.72 m (45 ft) from the impact location.

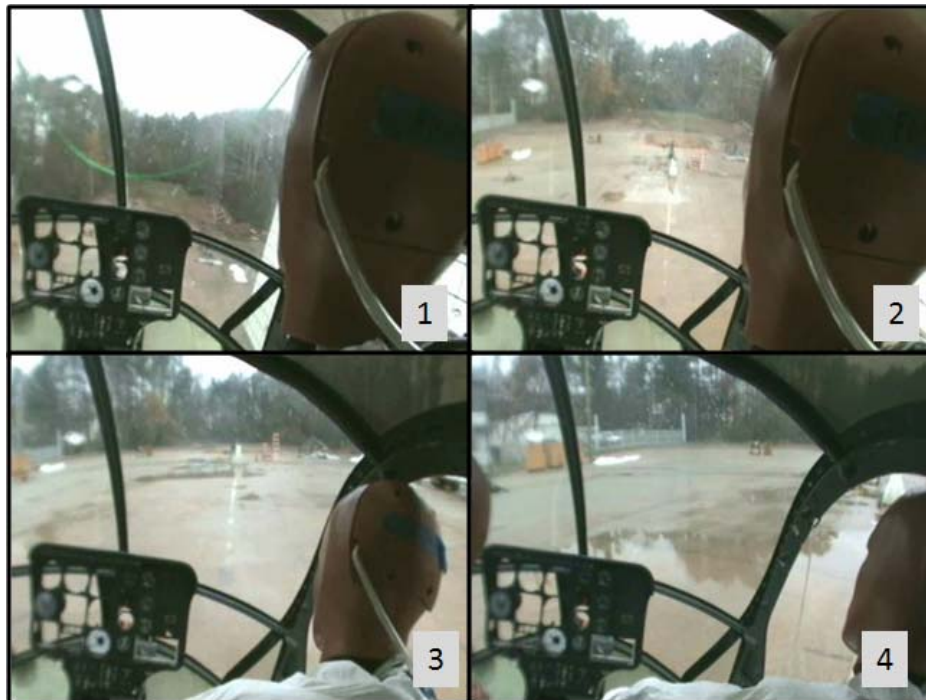
Figure 6 – Image sequence of impact viewed from an onboard camera.

Onboard cameras filming at 24 frames per second were used to capture the motion of the occupants before-, during-, and post-impact. In Figure 6, images 1 to 4 show a sequence from a forward facing camera mounted on the center bulkhead on the co-pilot side of the helicopter.

The back of the co-pilot ATD's head is in the right of each picture, while the avionics panel is in the lower left. The instrumentation cable is seen emanating from the back of the co-pilot's head. Picture 1 (upper left) in Figure 6 shows the vehicle resting at the drop height, before release. Picture 2 shows the vehicle midway through the swing, in which the pitch down attitude can be seen by noting the difference in the angle of the impact surface between it and picture 1. Picture 3 shows the vehicle as the DEA is crushing; when the vehicle has leveled to approximately zero pitch. Picture 4 shows the vehicle at rest after the impact. The helicopter turned toward the left after the impact, causing the co-pilot's head to flail to the right. Also note that the head is further away from the camera in the post-test image, indicating that the co-pilot ATD also lunged forward before being stopped by the seat belt restraints.

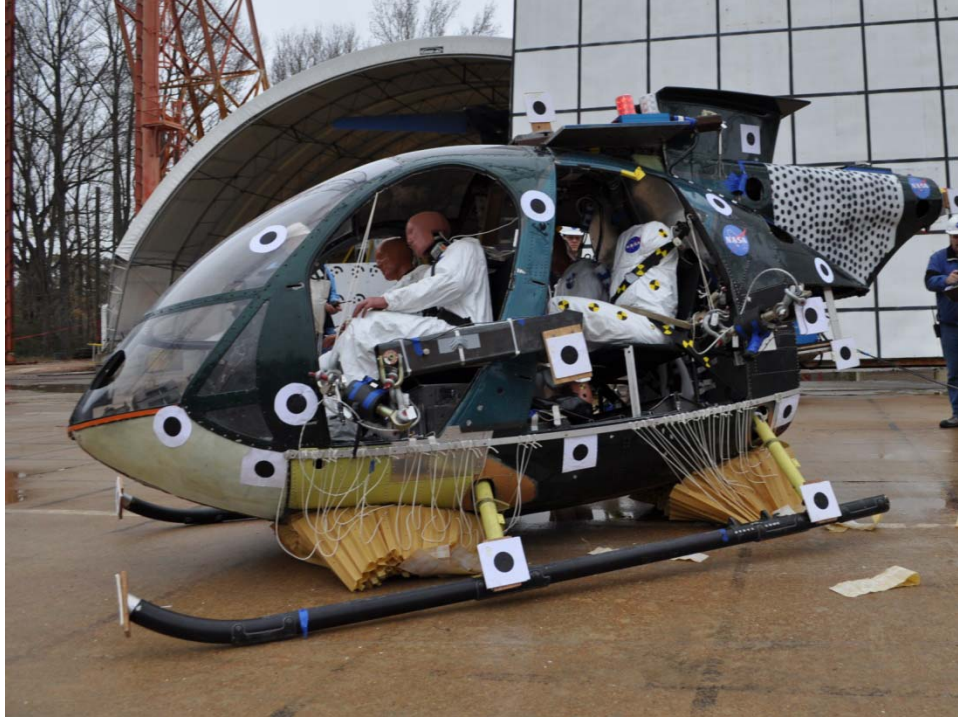
Figure 7 – MD-500 helicopter in post-impact location.

Figure 7 shows the airframe post-impact. The crushed DEAs can also be seen underneath the airframe.

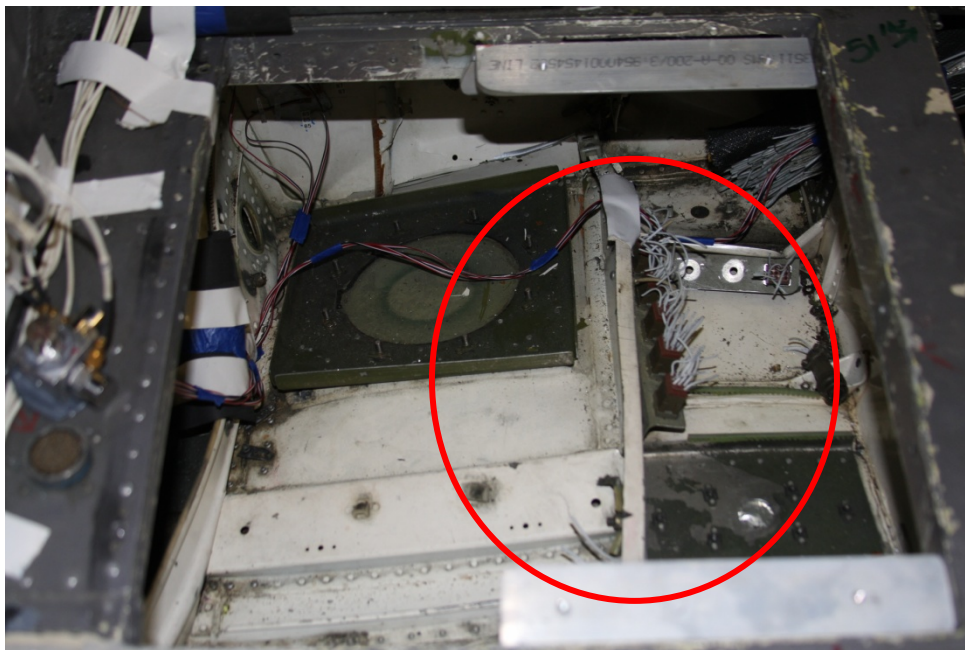
Figure 8 – Co-pilot subfloor and buckled frame.

Post-test inspection of the airframe showed very little damage on the main structural components of the airframe. The seats were also undamaged. The front airframe skin reacting against the forward DEA showed some minor buckling; however the large majority of the airframe's structure was undamaged. Figure 8 shows the co-pilot's side buckled subfloor, which reacted against the DEA crushing. Inside the circled portion is a buckled frame.

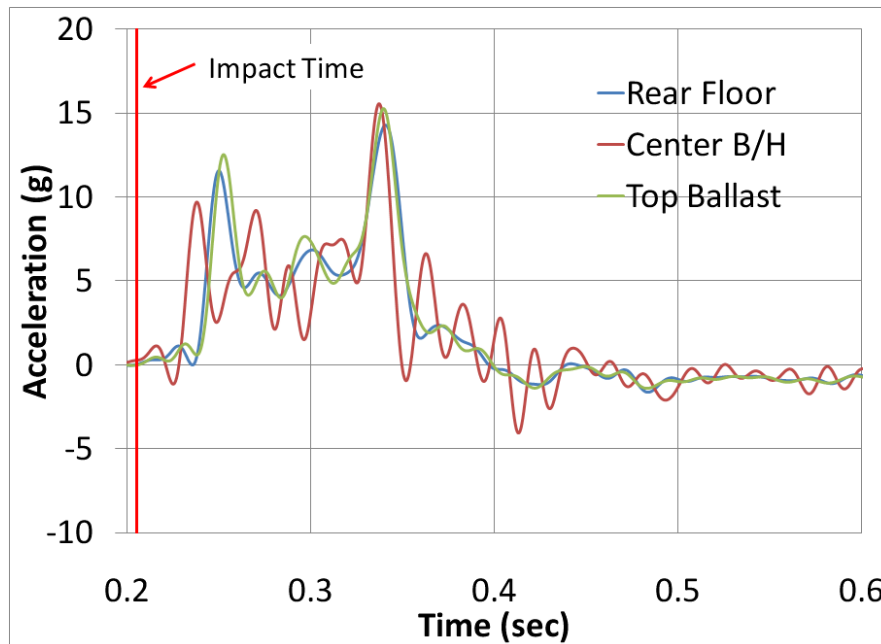
Figure 9 – Vertical accelerations from the airframe.

The accelerations from various portions of the airframe were also examined. Figure 9 shows vertical accelerations from the rear floor, front bulkhead, and top ballast mass. The “rear floor” accelerometer was positioned centered beneath the rear ATD’s feet. The “Center B/H” accelerometer was placed on the lifting hardware attached to the center bulkhead, directly behind the front seats. The “Top Ballast” accelerometer was placed on the mounting plate where the rotor blades would be attached. The accelerations are filtered using a four pole, 60 Hz. lowpass digital Butterworth filter. Note that in all plots, impact time is at 0.205 sec.

Figure 9 shows all three locations of vertical acceleration have generally the same response. Each has an initial spike at approximately 0.25 sec. Each then settles down to approximately 5 g and then spikes back up to 15 g around 0.35 sec. The first acceleration spike is attributed to the initial impact of the right front skid gear and the subsequent straightening of the vehicle before the DEA crush begins. The plateau between the spikes is the DEA crushing and absorbing the impact energy, while the 15 g spike near the end of the pulse is after the DEAs have reached their crush stroke limit. Horizontal accelerations are plotted next in Figure 10. The two accelerometers in Figure 10 are located on both the left and right side of the helicopter, on the floor and adjacent to the rear seat-to-floor attachment points.

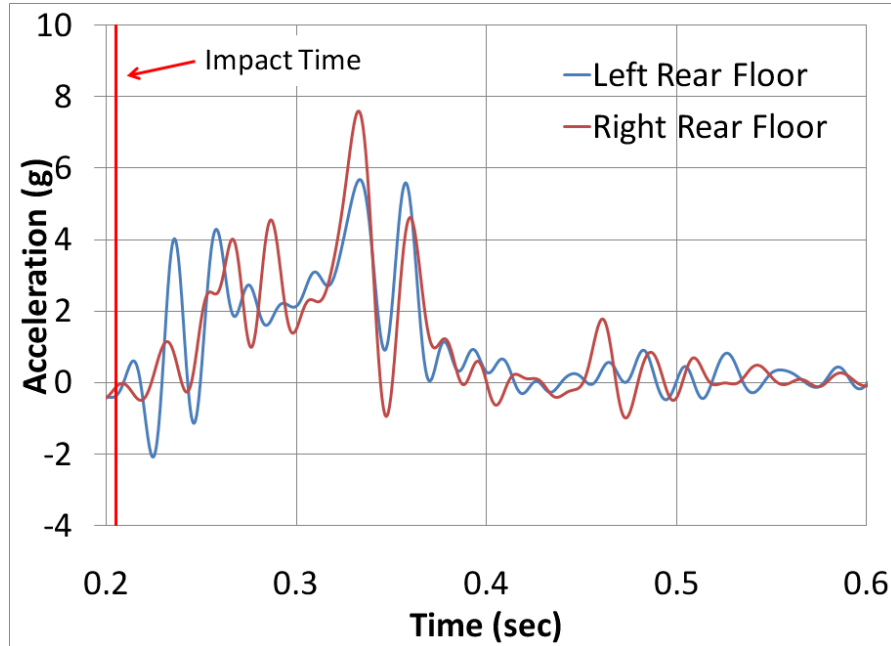
Figure 10 – Horizontal accelerations from the airframe.

The horizontal accelerations start to increase at approximately 0.2 sec, which is when the vehicle's front right skid gear reached the ground. The accelerations increase to approximately 7.6 g on the right and 5.7 g on the left side at approximately 0.33 sec, which is the point of maximum DEA contact, thus creating the largest frictional force between the DEA and ground. The right portion of the floor saw slightly higher accelerations, presumably from the fact that the right side of the vehicle impacted first.

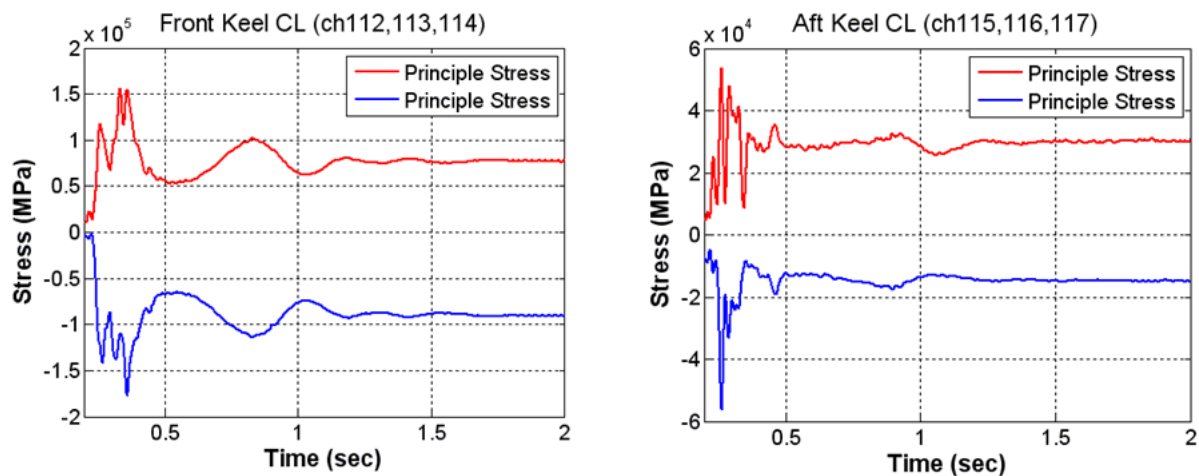
Figure 11 – Stresses on a forward (left) and aft (right) keel beam location.

Strains from the various structural members of the airframe were collected from strain gauge rosettes. Through strain transformation techniques and a modulus scaling factor, major and minor stress are plotted to determine post-impact structural integrity. On the skid gear, to assess the effect of bending strain, gages were placed inboard (toward the middle of the helicopter) and outboard (toward the outside of the helicopter) in pairs, and also placed forward (toward the front) and aft (toward the rear) in pairs. Representative plots are shown in Figure 11 for strains on a forward and aft location of the keel beam. Right front skid gear stresses are shown in Figure 12.

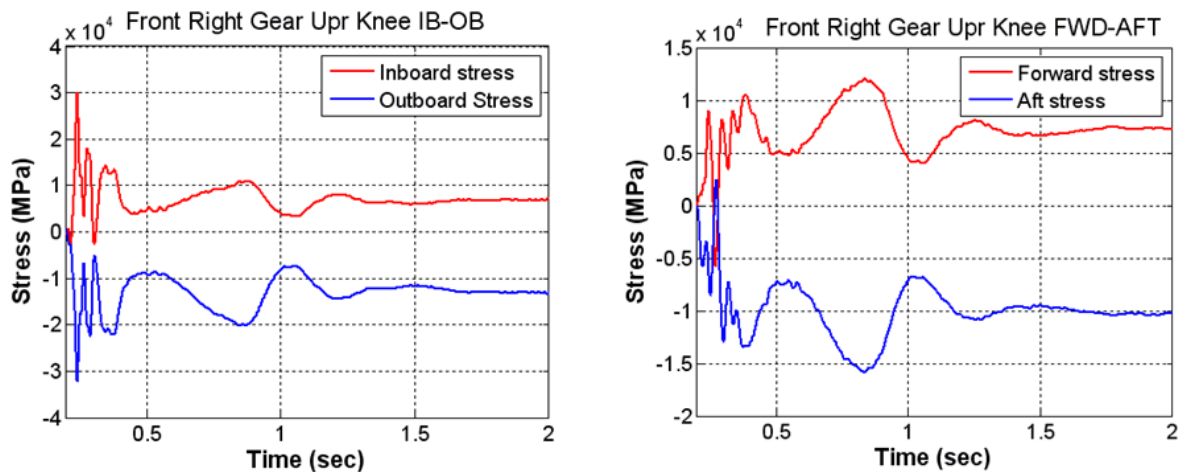
Figure 12 –Inboard and Outboard (left) and Forward and Aft (right) stresses on the front right skid gear.

All skid gear stresses were well within the elastic range for aluminum and showed no plastic deformation on the measured locations, which was 7.62 cm (3 in) above the curved “knee” of the skid gear. The right skid gear did exhibit some plastic deformation in areas which contacted the airframe structure which was higher than the left side, presumably because the helicopter impacted on the right side initially. However, no areas of either gear failed. This behavior was fortunate because the skid gears acted as outriggers and helped to stabilize the helicopter as it impacted and as the DEA crushed.

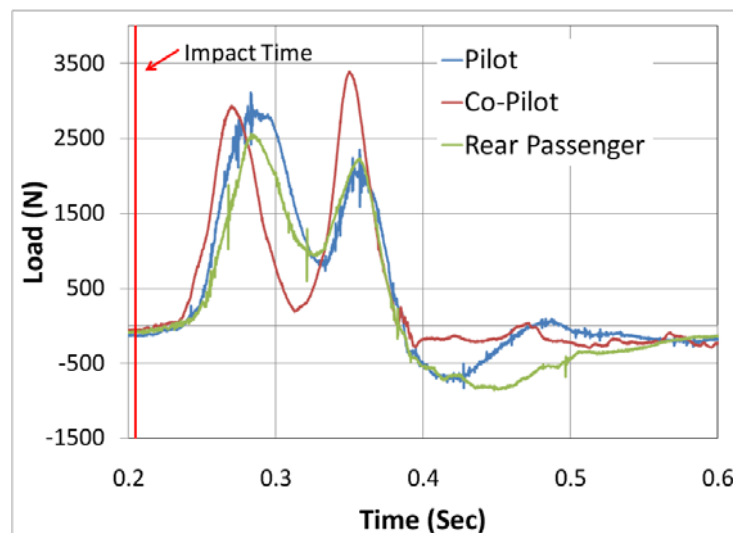
Figure 13 – Lumbar loads from three occupants.

The instrumented ATDs were also examined to assess the risk of occupant injury. One of the main ways to assess occupant injury is to examine the loads measured from a load cell mounted in the lumbar region of each ATD and compare it to the established limits in FAR Part 27.562 (C) [22]. Lumbar loads from the occupants equipped with lumbar load cells are shown in Figure 13. Note the rear left HSTM did not have a lumbar load cell, and thus is not plotted in Figure 13.

Figure 13 shows that the maximum lumbar load occurred in the co-pilot, which was most likely due to the vehicle impact on the right side first. However, examining the plots, one can note that the general response is similar for all three occupants. There is an initial peak around 0.275 sec, which represents the dummies impacting against their seats. The plots then reach a relative minimum before they reach a second peak at approximately 0.35 sec. The peak load for all three plots was 3380 N (755 lbs). When evaluating potential for injury for a 50<sup>th</sup> percentile occupant, FAR Part 27.562 (c) establishes a lumbar limit of 6672 N (1,500 lbs) as being injurious. The loads incurred in the occupants were well below this limit.

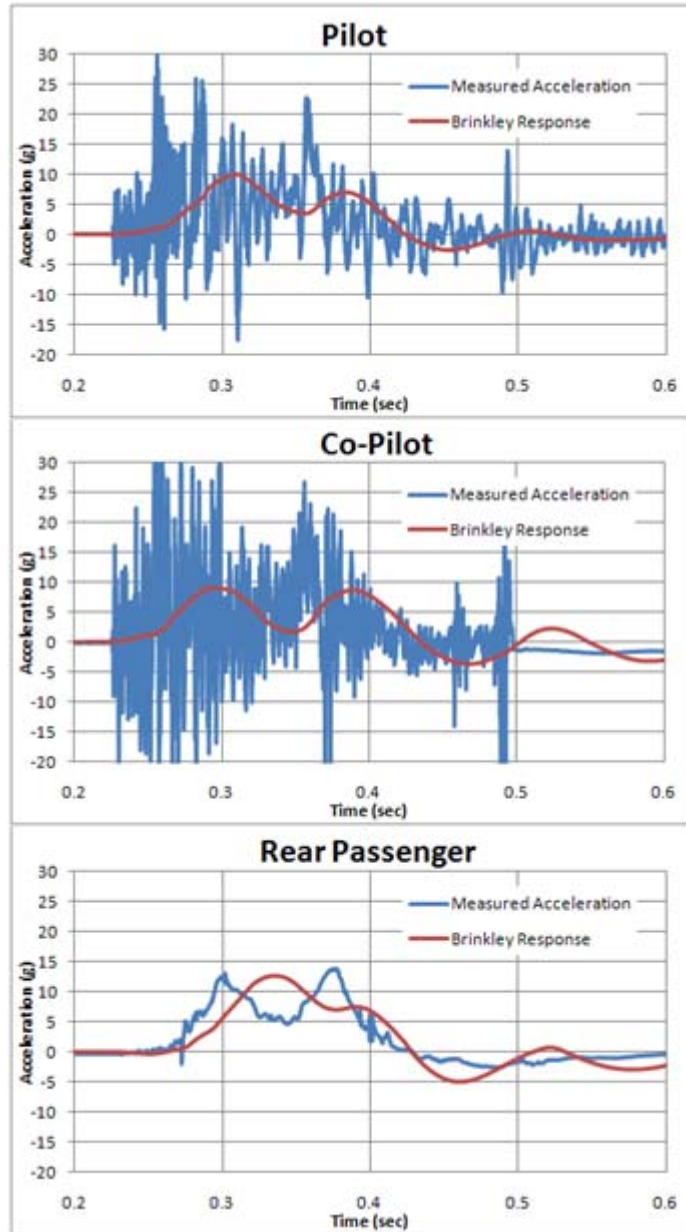
Figure 14 – Measured vertical seat pan time histories and dynamic response for each occupant from the Brinkley model.

Table 1 indicates that the probability of injury in the pilot, co-pilot or rear passenger is below the low category, indicating a very low probability of risk. Next, dynamic response time histories for each occupant were output from the Brinkley model, and Figure 14 shows both the seat pan accelerations and the Brinkley dynamic response.

The time histories shown in Figure 14 are the measured seat pan accelerations compared to the Brinkley responses for each occupant. Notice in the Brinkley responses, the front pilot and co-pilot have very similar time histories while the rear passenger is slightly different. This difference can be attributed to the differences in seats. The front pilot and co-pilot were in identical mesh bucket seats, while the rear passenger was in a mesh bench seat. The response data shows that the front occupants saw a 9-10 g dynamic response at 0.3 sec. These results, along with the beta value, show that there is a very low risk of injury to the occupants.

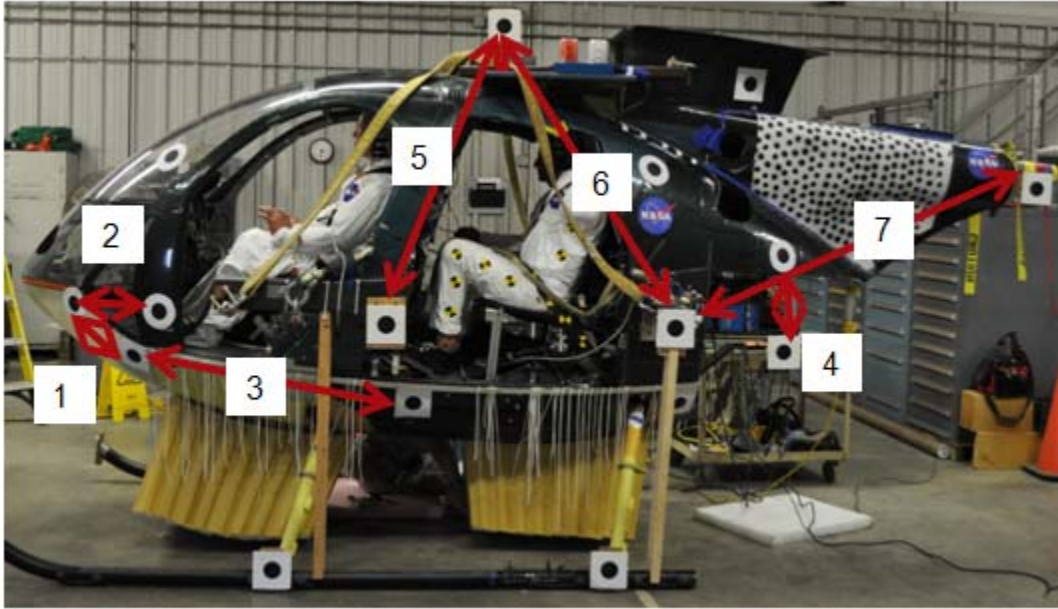
Figure 16 – Vehicle target locations for deformation measurements.

Finally, relative deflection between the discrete points on the helicopter was examined. Areas of large relative deflection on the aircraft suggested possible compromises in structural integrity and possible damage. Figure 16 shows the locations and identification of the points, while Table 2 shows the results.

Table 2 shows the highest relative displacements occurred in the front of the vehicle, and near the rear of the vehicle labeled “DAS Shelf Support”. The relative displacements that occurred in the front of the vehicle were from the nose impacting the surface first due to the pitched down orientation of the helicopter at impact. At impact, the DEA began crushing pushing the nearest targets (located at positions

1 and 2 in Figure 16) upward while the ballast mass in the nose of the aircraft continued at a downward trajectory. However, the photogrammetry showed that there was no permanent deflection, thus the nose rebounded back into place. The other area of high relative deflection was near the rear of the helicopter, under the tail support, in position 4. Position 4 measured the relative deflection on a connection bar between the aircraft frame and a metal plate which held the onboard data acquisition system. The plate with the acquisition system weighed approximately 68 kg. (150 lbs), and was cantilevered from brackets attached to the rear bulkhead. As the helicopter impacted the surface and rebounded, the shelf's momentum caused it to deform the bar or the frame enough to be calculated by the photogrammetry system. However, as with the helicopter nose, the deformation was not permanent and the bar elastically rebounded to its initial position. All other areas examined exhibited low deflection, and confirmed the findings from the visual inspections that the airframe was relatively undamaged.
